Lincoln County Fairgrounds Facility Observation

LRS
ARCHITECTS

January 21, 2014

FAIR GROUNDS BUILDING CONDITIONS AS OF 5/21/2013

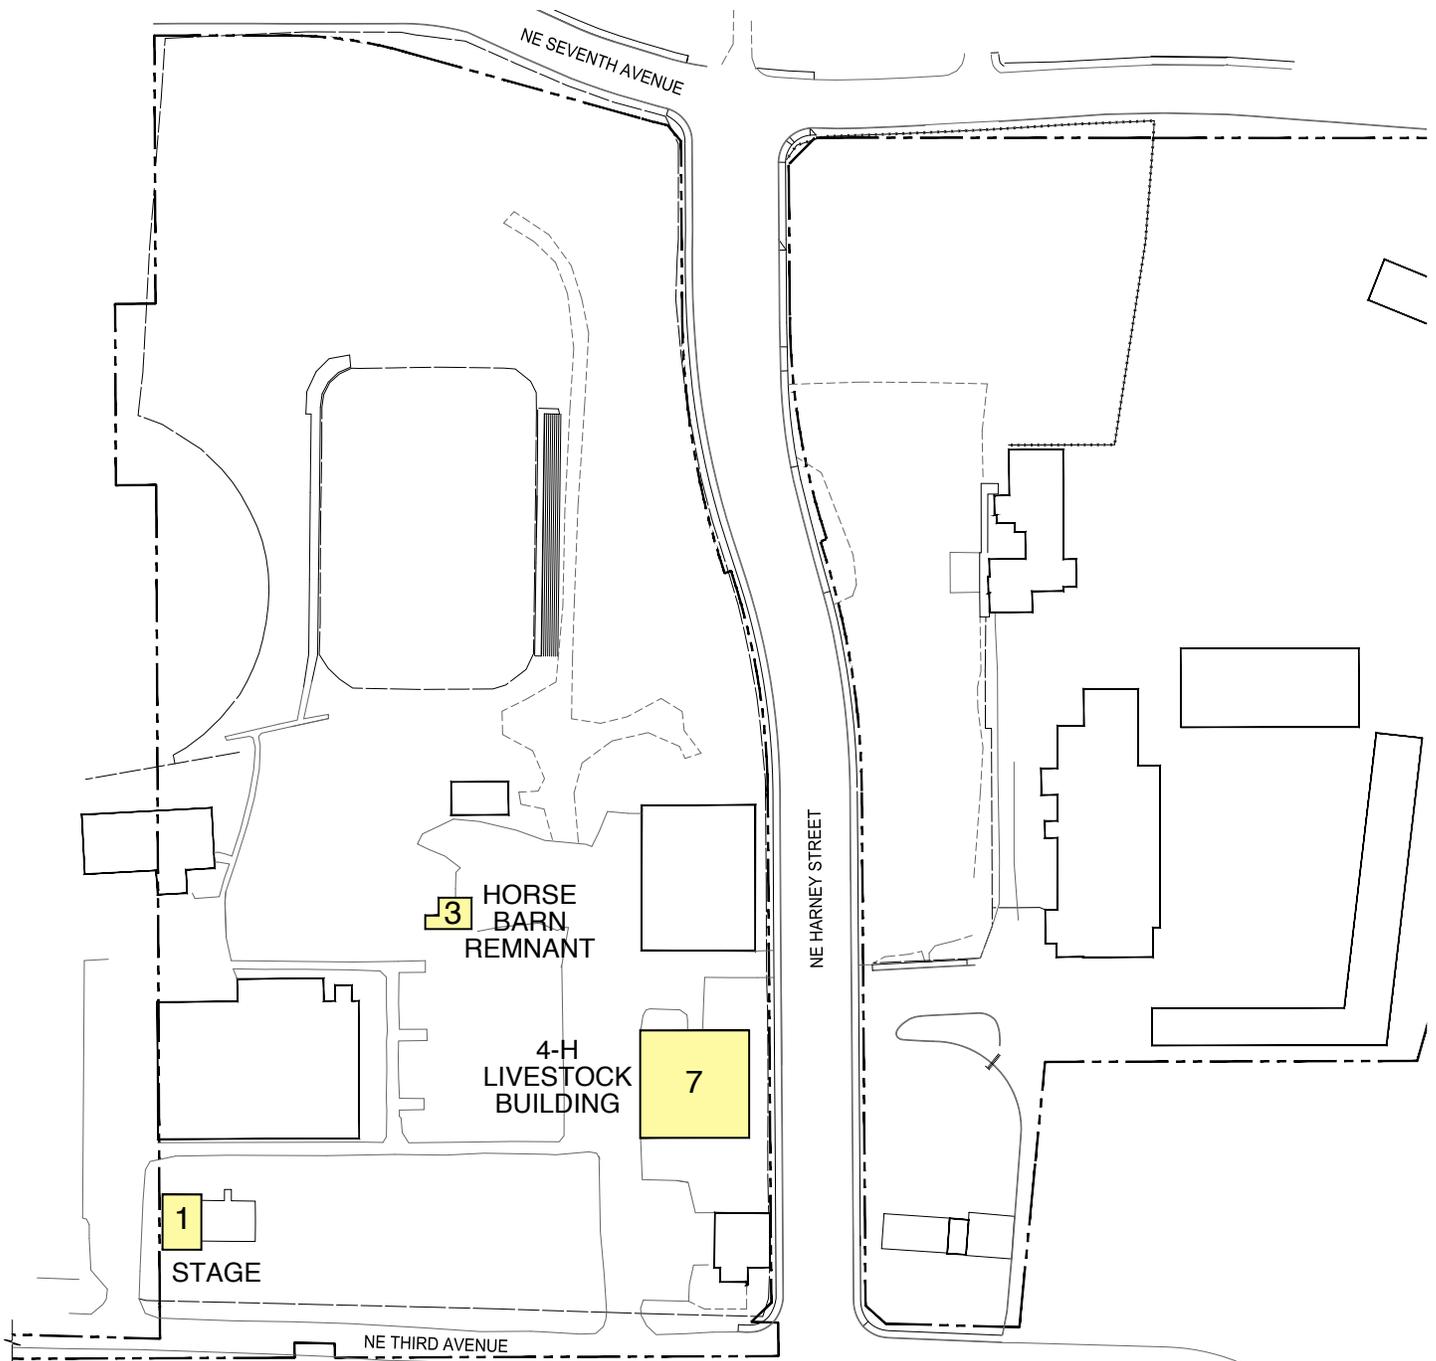
1. EXISTING SITE PLAN

FAIR CONDITION

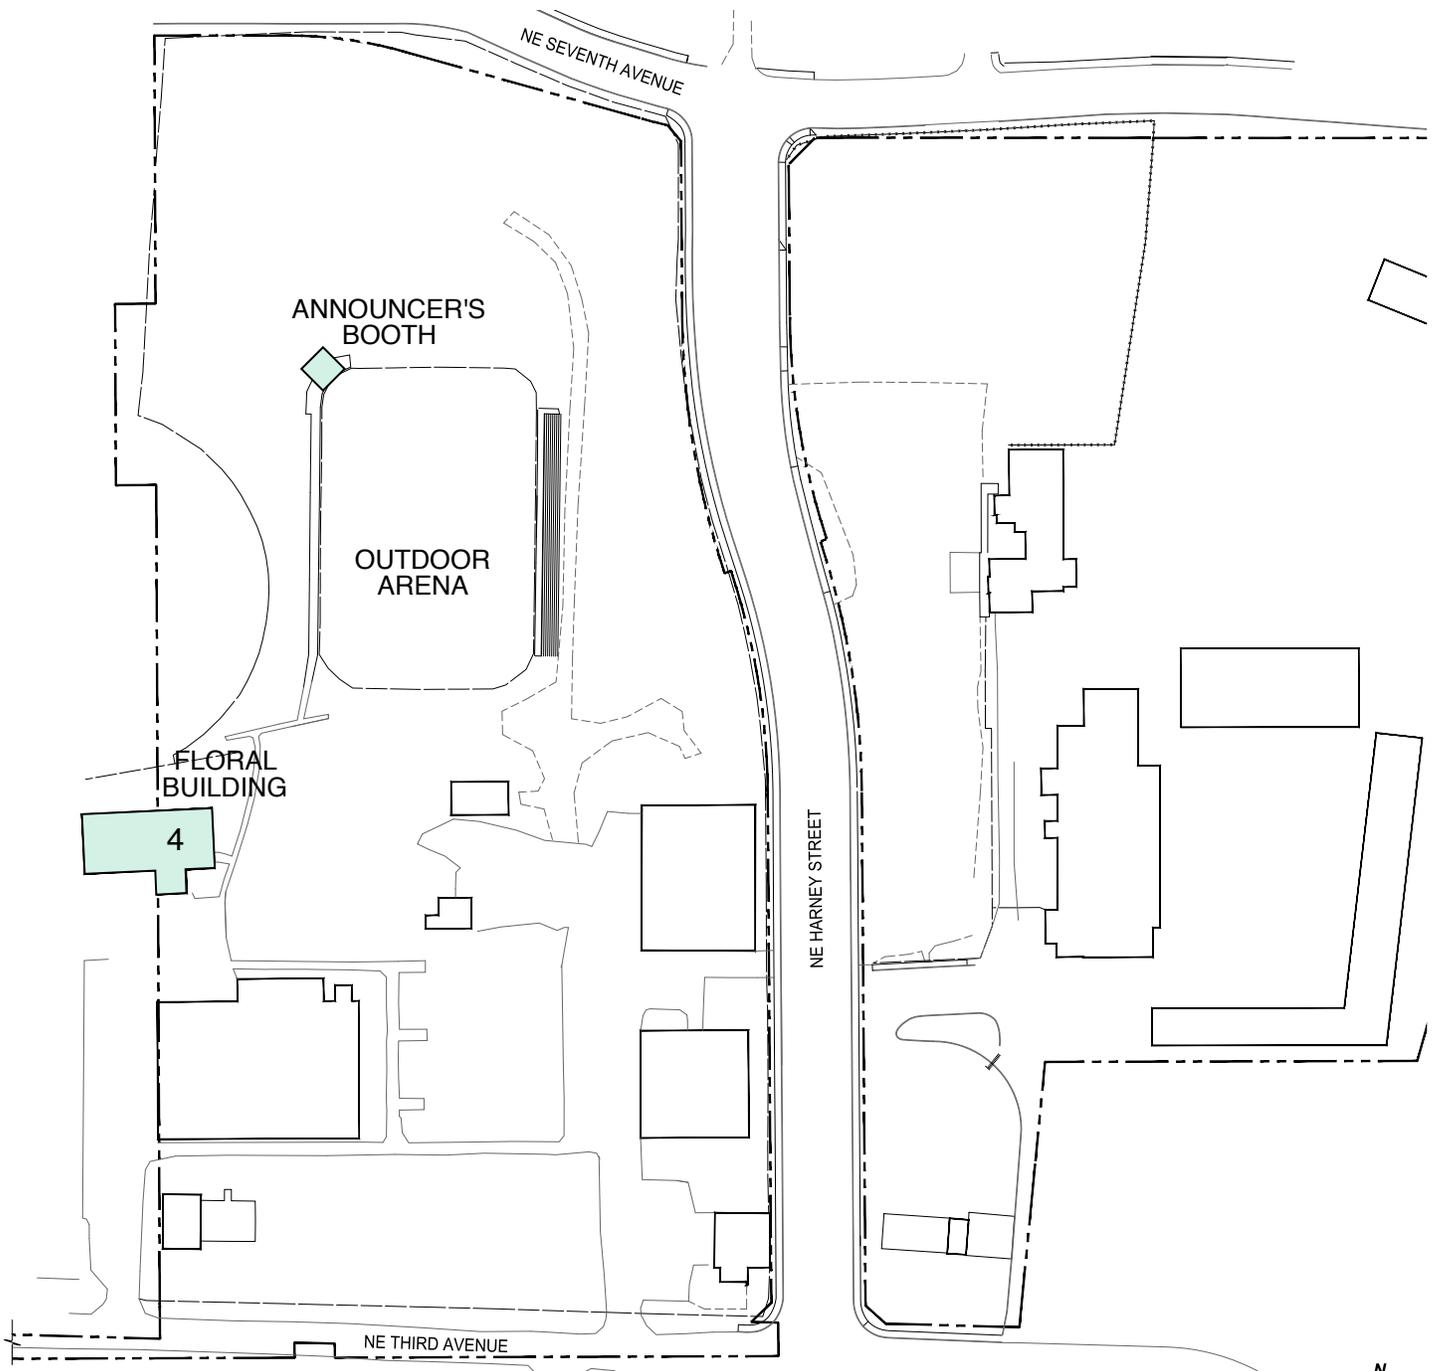
1. EXISTING SITE PLAN

GOOD CONDITION

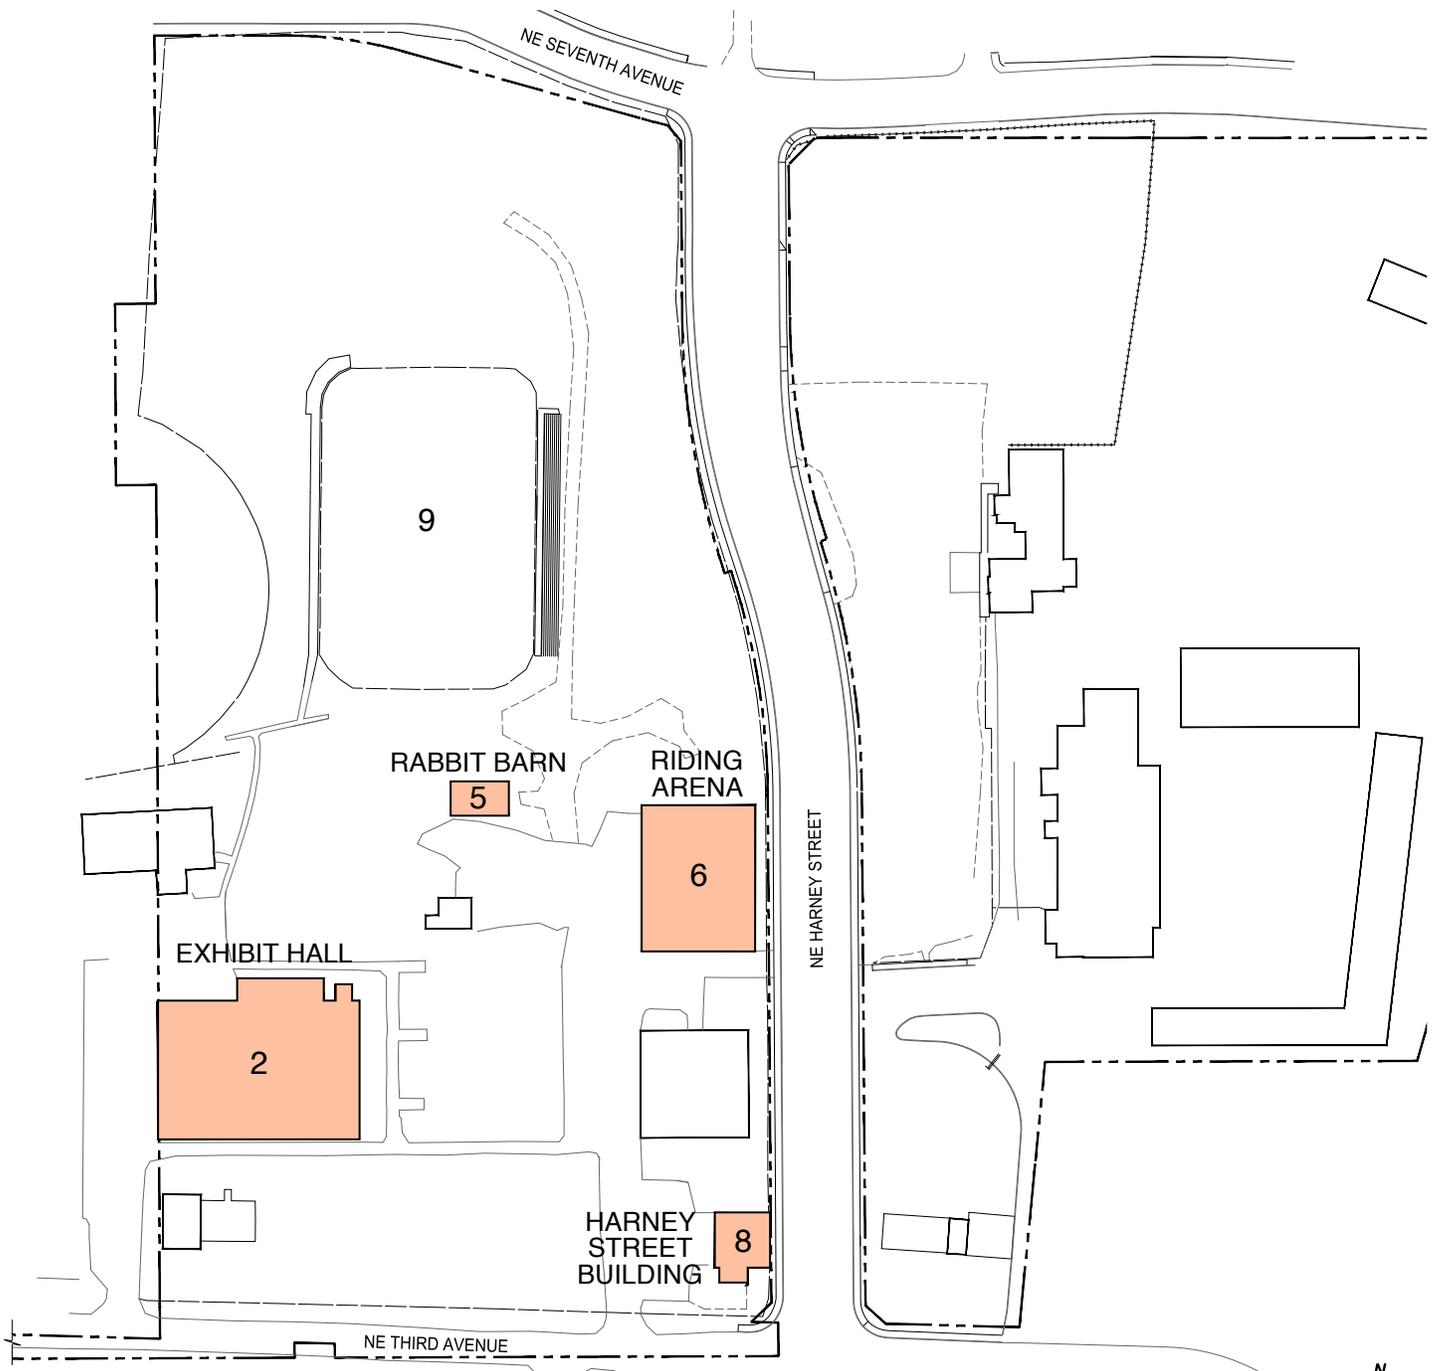
1. EXISTING SITE PLAN

POOR CONDITION
