**EXISTING CONDITIONS**

**DEFINE THE PROBLEM**

**PROPOSED SOLUTION**

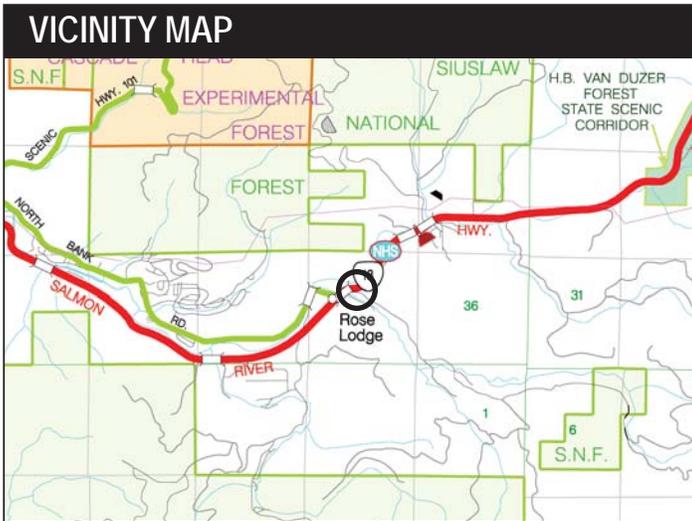
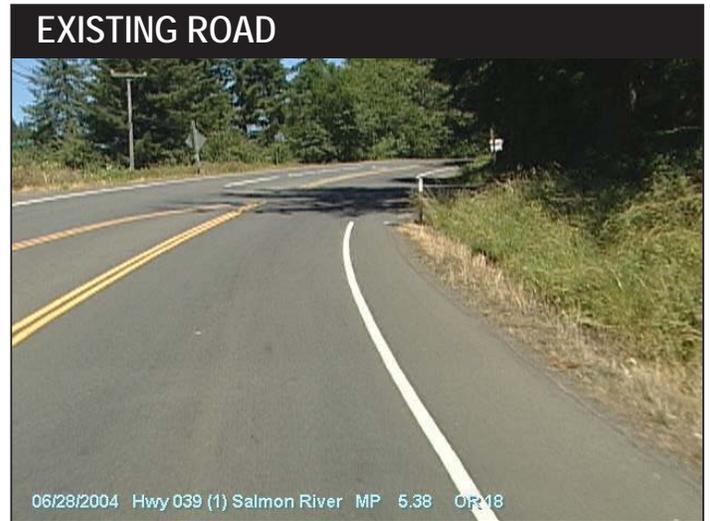
Located on a curve, north leg of intersection not visible from highway

Enforce speed; Manage vegetation; Re-stripe; Install flashing yellow caution beacon; Install reflective posts along the edge of the roadway
